MINOLTA® PAGEPRO 8 • PAGEWORKS 8 TONER CARTRIDGE REMANUFACTURING INSTRUCTIONS

REMANUFACTURING THE MINOLTA PAGEWORKS 8 TONER CARTRIDGE

By Mike Josiah and the Technical Staff at UniNet

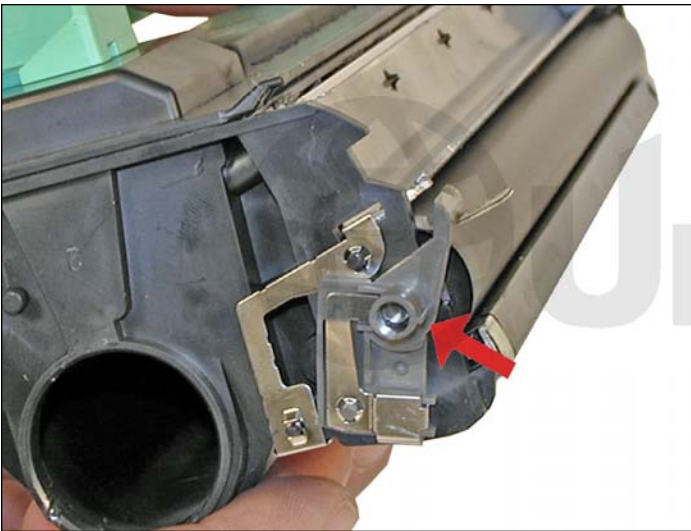
4. Remove the small hubs from both sides of the developer roller.

The contact hub is removed from the left side and the non-contact hub from the right.

These hubs can be black or gray in color.
